NATIONAL PROGRAM FOR INSPECTION OF NON-FEDERAL DAMS
LYNDE BROOK RESERVOIR. (U) CORPS OF ENGINEERS WALTHAM
MA NEW ENGLAND DIV MAY 80

LYNDE BROOK RESERVOIR DAM

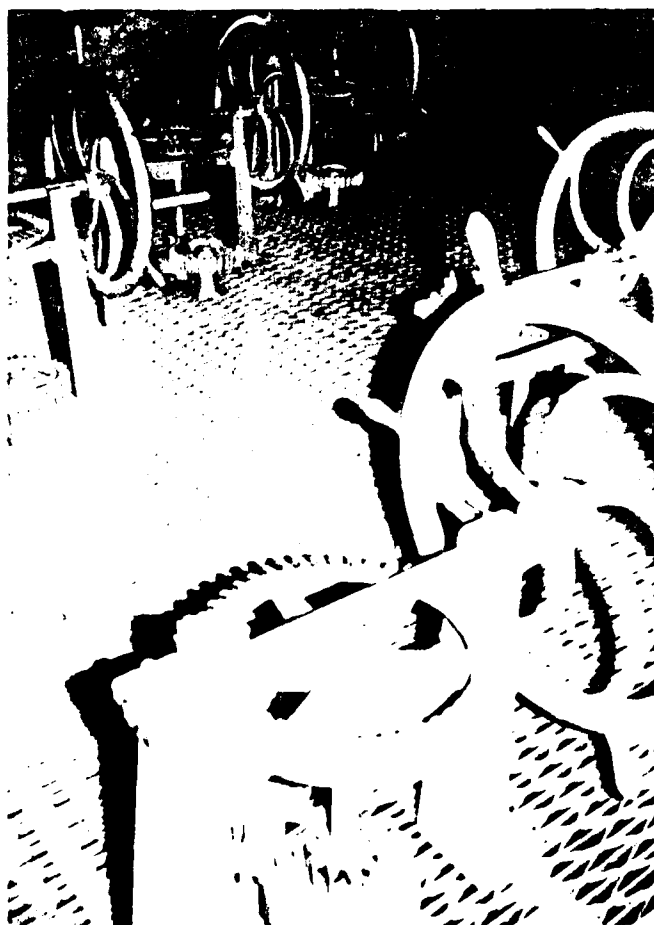
13. Manual operating mechanisms in first floor of gate house at downstream toe of dam.

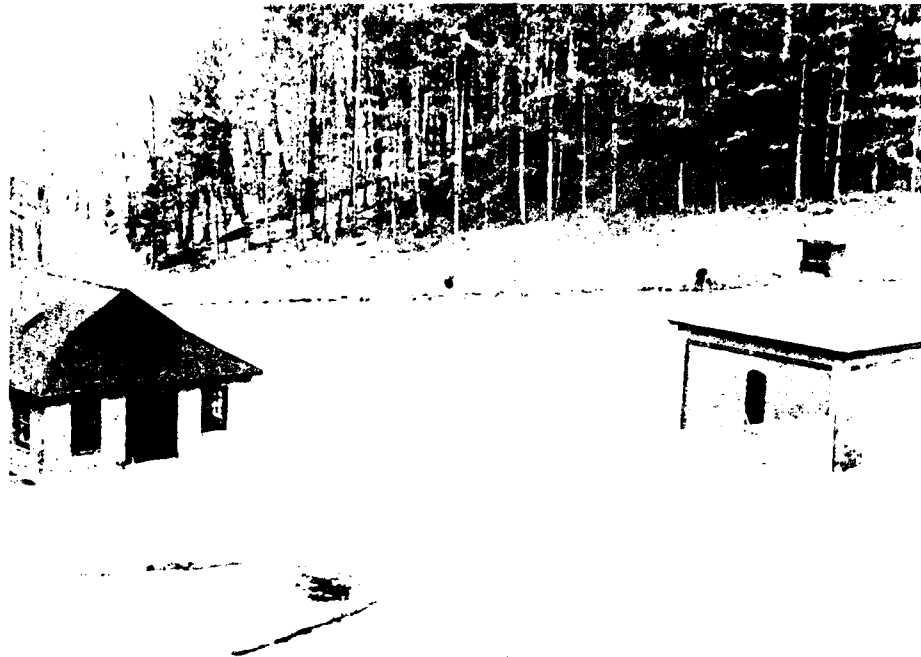
11. Outlet gate house on right and chlorination building on left at downstream toe of dam.

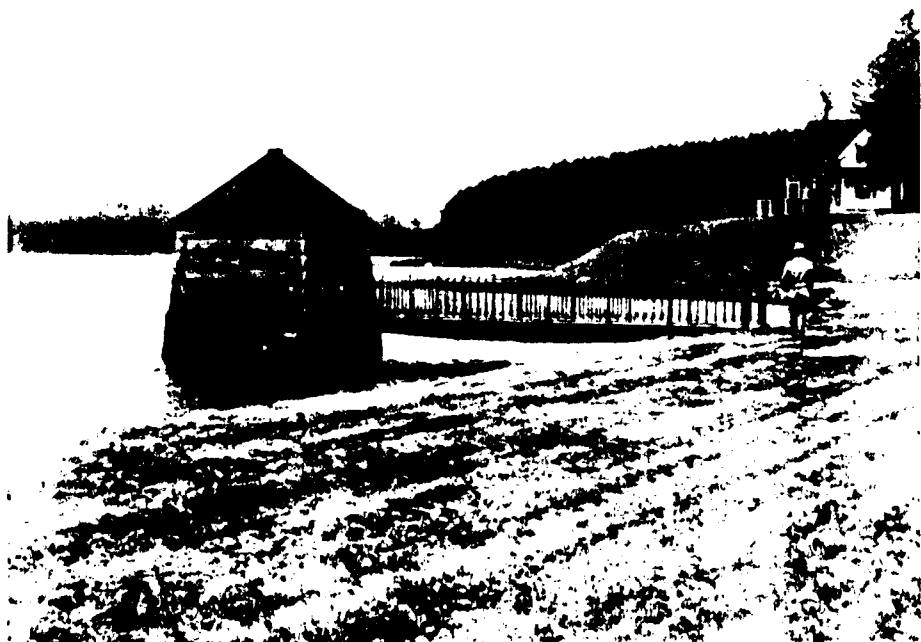
12. Barn house at north end of East Hill

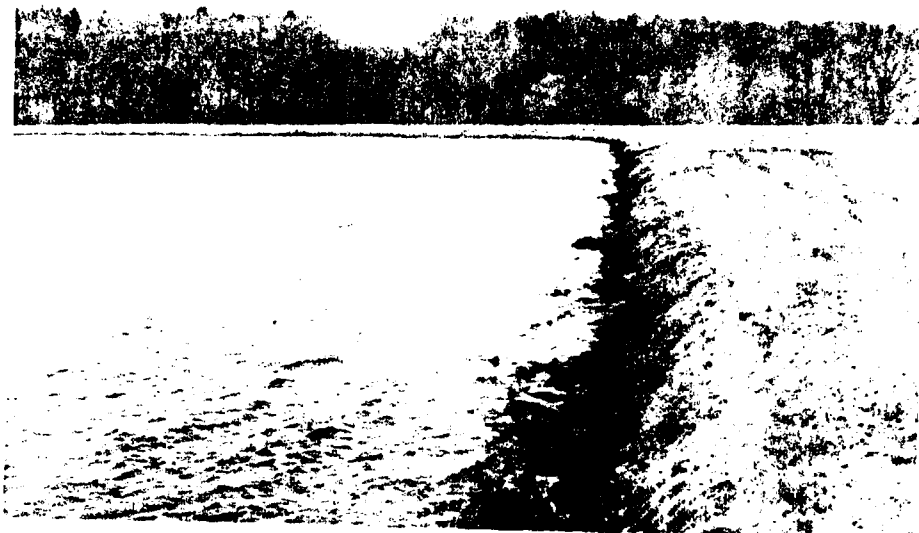
1. Upstream slope of dam
